## KEMNAY COMMUNITY COUNCIL

### FORMAL REQUEST FOR KEMNAY FLOOD RISK ASSESSMENT COVERING CAUSE, IMPACT AND SOLUTIONS

#### **Attachment 2 – Report (08.07.2016)**

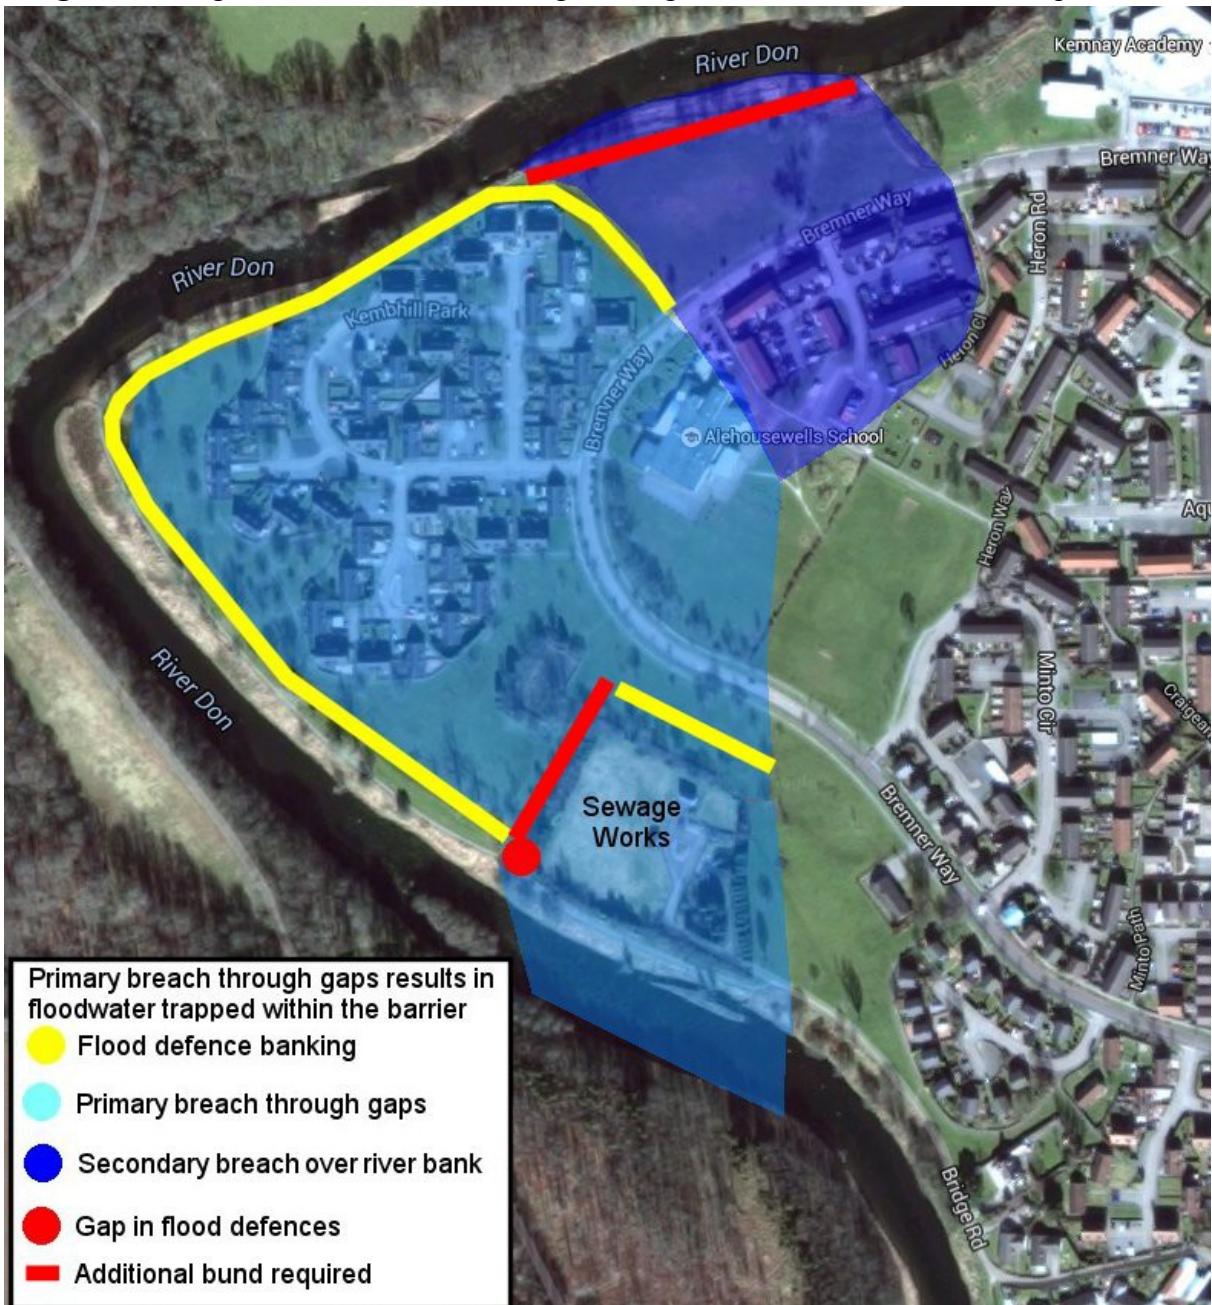
**2 KEMBHILL PARK** (see Figs. 14 & 15) Flooding occurred here due to the River Don initially flowing through a gap in the flood bund between the existing flood bund and the wire mesh boundary fence surrounding the Sewage Pumping Station. The Pumping Station was eventually overwhelmed and there were reports of raw sewage escaping out onto public open spaces, roads and residential properties. A considerable number of houses experienced further flooding when toilets backed up and flooded the interior of the houses, which suggests that the houses in Kembhill Park drain to a combined sewer. Further flooding occurred just north of Kembhill Park just beyond the flood bund where the River Don burst its banks and flooded onto the football pitch and continued south to flood a number of residential properties in Bremner Way as well as Alehousewells Primary School. See Fig. 1 showing the approximate area of flooding, the gap in flood bund plus the existing and additional flood bund requirements.

**Fig. 1** Flooding at Kembhill Park showing existing bund and additional bund requirements

1. Additional flood bund at Kembhill Park (north and south), as indicated in red in Fig. 7. 2.
2. Investigation of possible mitigation measures that can be carried out further upriver along the River Don, which may be creation of floodplains to reduce the impact of flooding.
3. Creation of an ongoing maintenance programme to ensure that road gullies are clear and not obstructed.

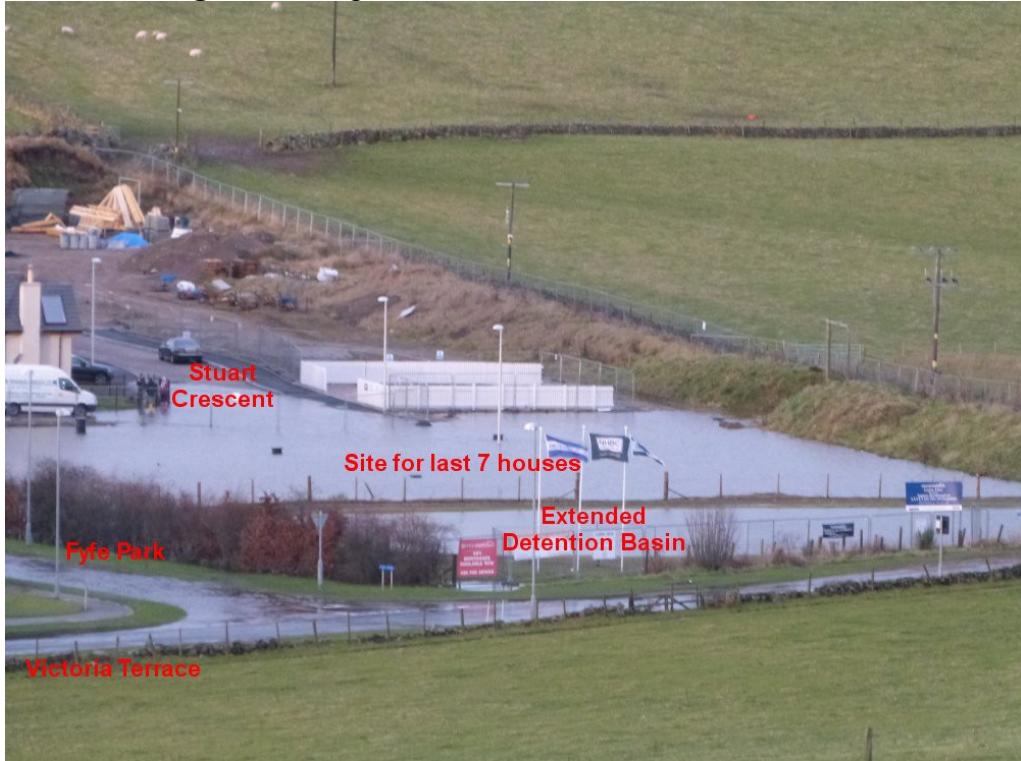
In December 2013, prior to completion of this development, there was serious flooding of the lower southern part of the site. At the time, unusual weather conditions prevailed, the ground had been frozen solid for a prolonged period, which was followed by prolonged heavy rainfall. The frozen ground conditions could not absorb the rain, which just drained down the hill and accumulated in the historically flooded area adjacent to the B993. Kemnay Community Council reported the flooding to Aberdeenshire Council and supplied photographic evidence (see Fig. 2) but the remaining 7 houses were still constructed. On the day of the floods, the sewers in Victoria Terrace were overwhelmed with the amount of surface water and in consequence both Detention Basins overflowed resulting in flooding at Stewart Crescent and the junction at Fyfe Park / Victoria Terrace. In addition, road gullies backed up at the historic flooding site at Kirkstyle Garage, Victoria Terrace, flooding the Garage and other properties further east along Victoria Terrace. Post flood attempts were made to clear the surface water sewer, but it became apparent the there is an obstruction somewhere between Parkhill and Bogbeth Road.

**Fig. 2 Flooding at Stewart Crescent in December 2013**

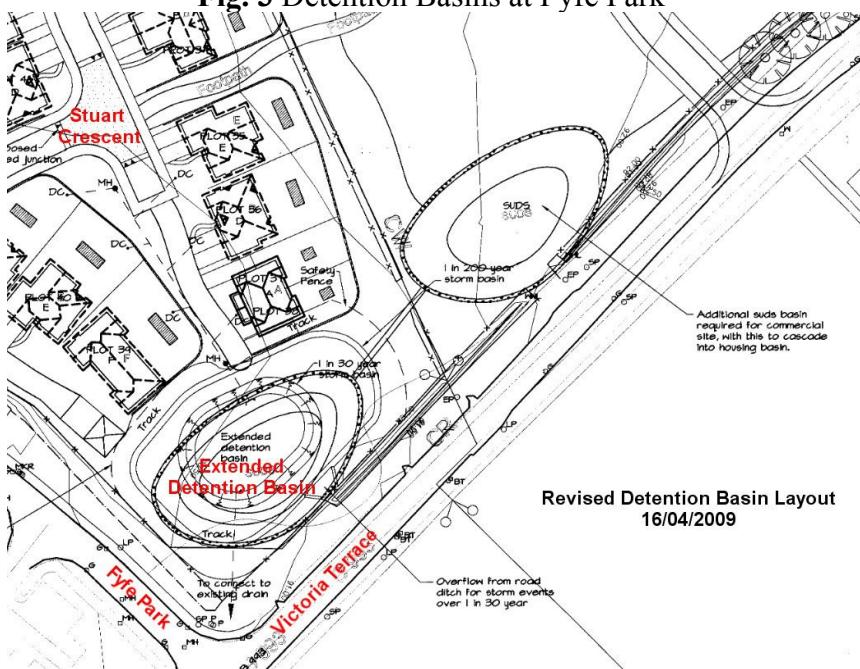
As pointed out above, this has been a long lasting historical problem acknowledged by former Grampian Regional Council and Gordon District Councils in 1993 (see Fig. 9). Although GRC and GDC accepted that the sewers were inadequate, 96 houses were built at Kirkstyle in 1997 utilising a SUDS. Due to the inadequate sewers in Victoria Terrace, foul sewage is pumped over the hill to the STW and surface water drained to individual soakaways with the addition of a large soakaway sited to the east of Fyfe Park. In 2011 a further 54 houses were built east of Fyfe Park, again using a SUDS with the addition of two Detention Basins, which discharge into the acknowledged inadequate sewage infrastructure in Victoria Terrace (see Fig.3).

**Fig. 3 Detention Basins at Fyfe Park**

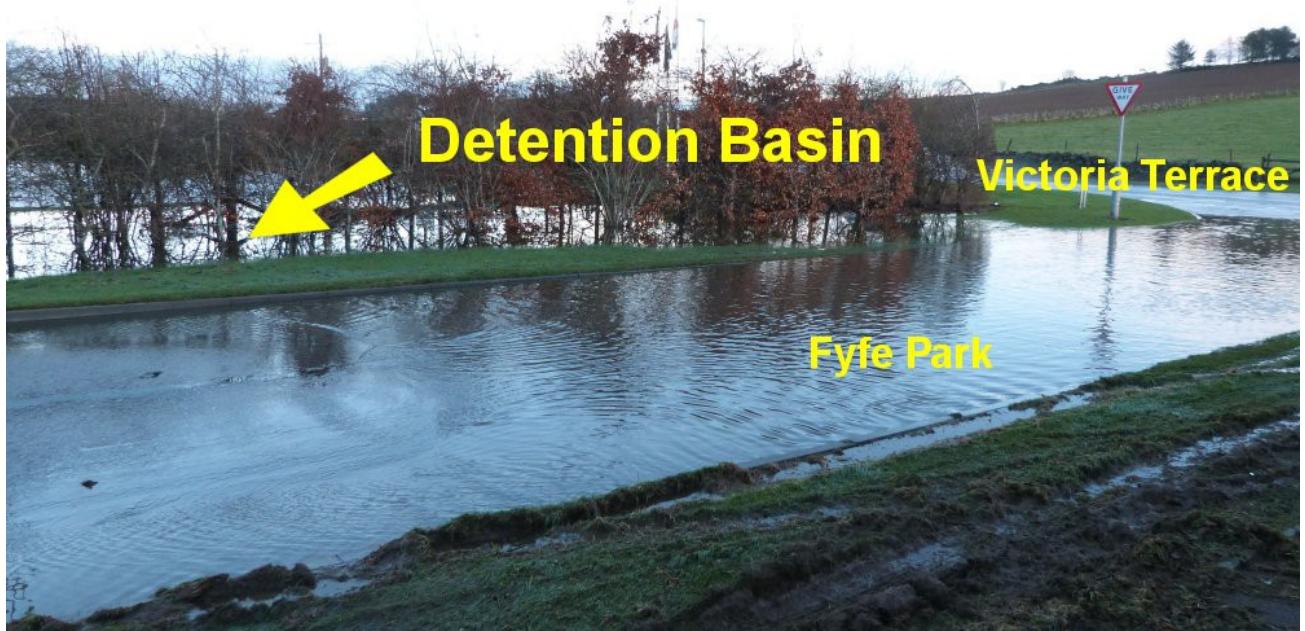
**3 FYFE PARK / STEWART CRESCENT / VICTORIA TERRACE** The January 2016 flooding in these areas would appear to be related to inadequate sewer capacity in Victoria Terrace and some detail of the historical flooding events over the years follows. There are a number of measures that

**Fig. 4** Flooding at junction of Fyfe Park and Victoria Terrace January 2016

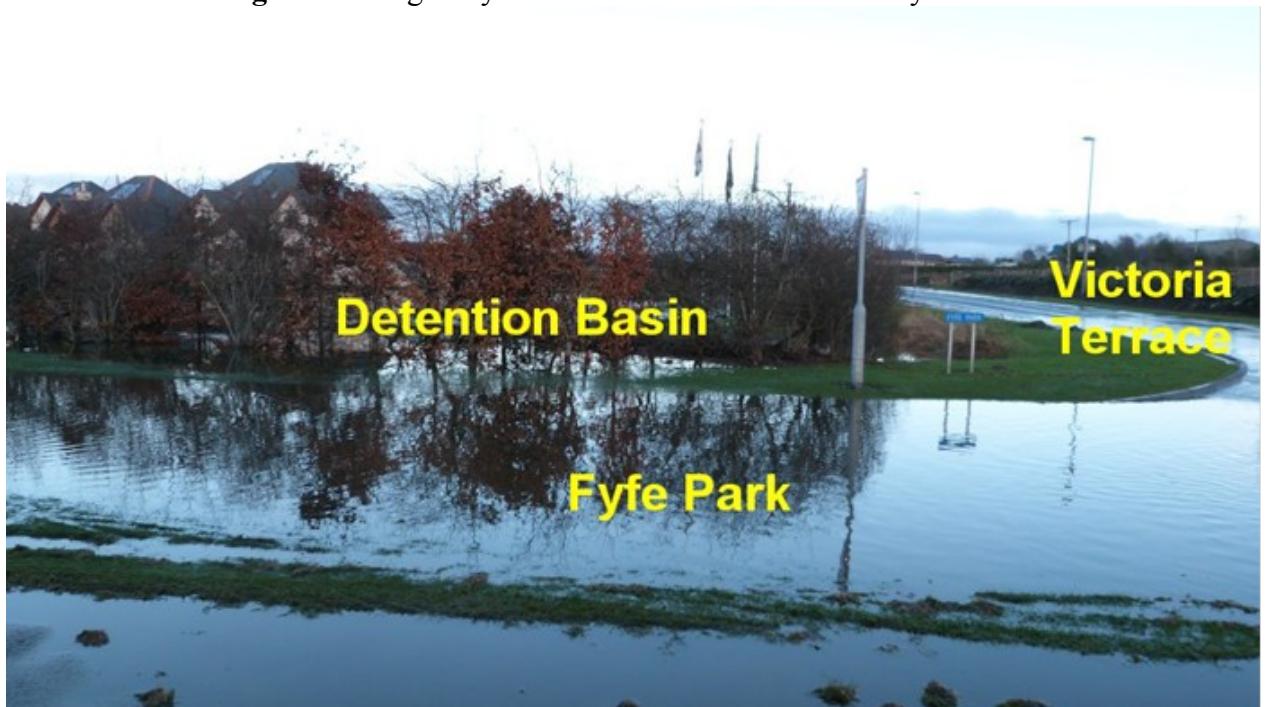
**Fig. 5** Flooding at Fyfe Park / Victoria Terrace January 2016

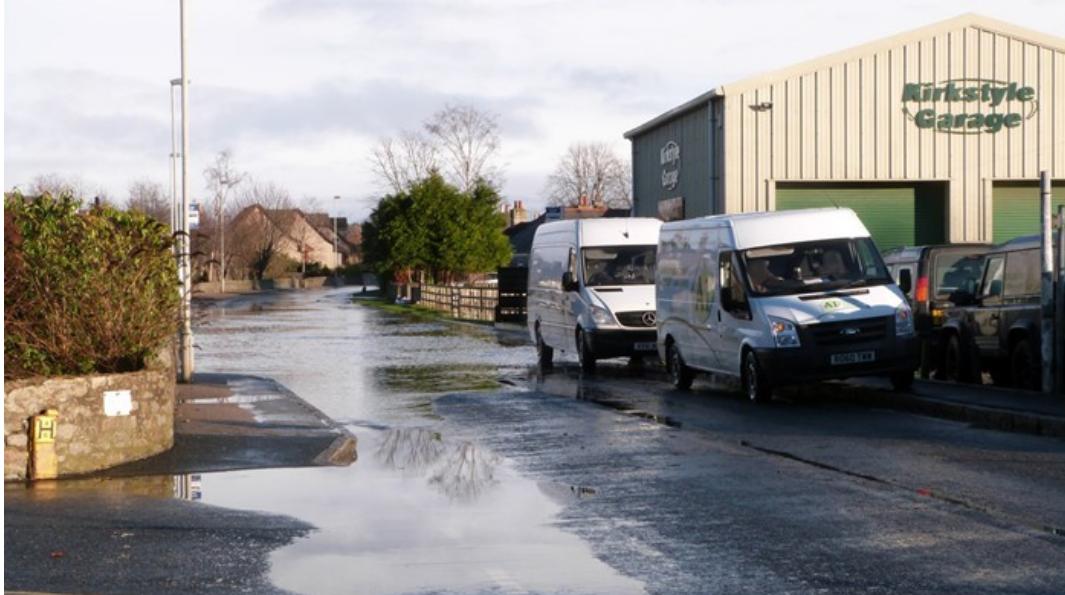
**Fig. 6** Flooding at Victoria Terrace January 2016

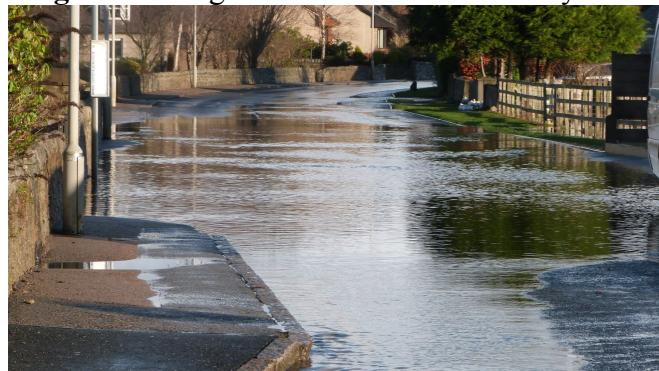
**Fig. 7** Flooding at Victoria Terrace January 2016

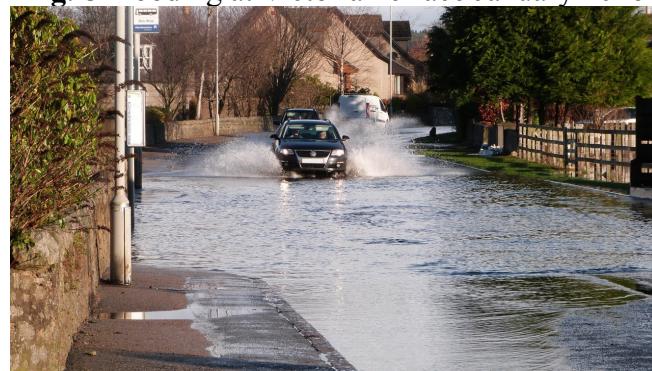
**Fig. 8** Flooding at Victoria Terrace January 2016

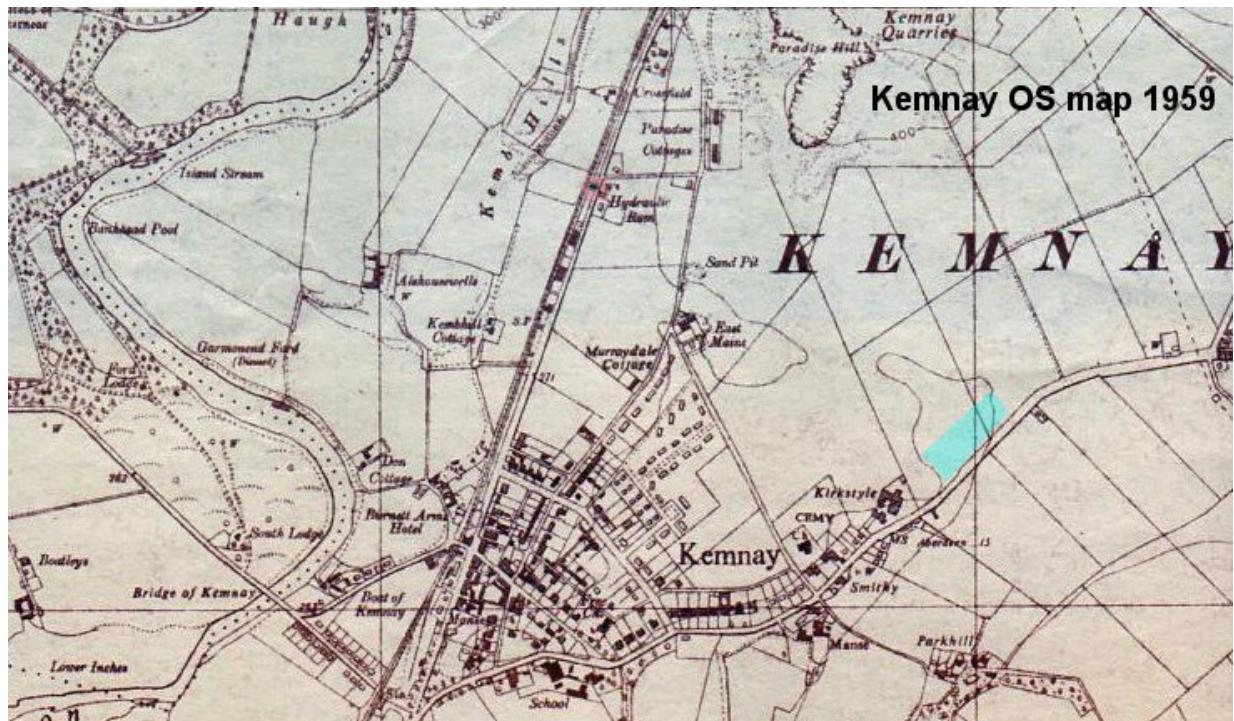
Flooding in Victoria Terrace has been occurring for many years, certainly since the 1980's but some reports go back further to the 1970's and indeed further back. The area shaded blue, on the 1959 OS map of Kemnay below, indicates roughly an area of farmland that has historically been prone to flooding (see Fig. 10). This has indisputably been an area susceptible to flooding and at some time between 1980 and 1985, the owner of the farmland carried out extensive engineering works, grading, levelling and draining the site. However, during periods of heavy prolonged rainfall or during melting winter snows, the site continued to flood.

**Fig. 10** showing where historic flooding occurred

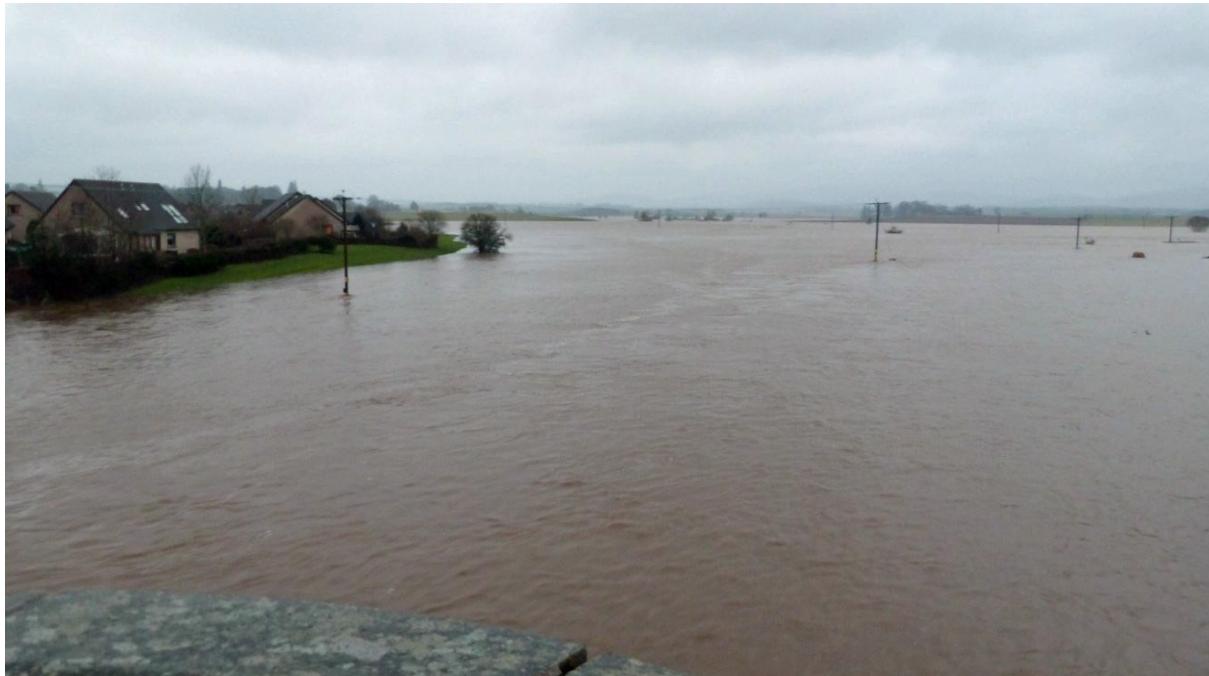
**1 MILTON MEADOWS** (see Figs. 12 & 13) The main cause of flooding in Milton Meadows was attributed to surface water road gullies backing up as a result of River Don level rising above the outflow level of the road gullies. In addition, the lack of regular maintenance to the gullies hindered the ability of the gullies to cope with the volume of water and its ability to remove the flood threat. However, the level of River Don came close to a height that would have caused flooding to extend further and beyond the estate, thereby potentially causing a disaster of greater magnitude. The sewage pumping station proved to be inadequate during this event and requires to be either upgraded or a suitable solution found. Potential flooding and drainage problems were brought to the attention of former Gordon District Council in December 1996 when Kemnay Community Council commented on planning application 96/1261/01. Reference was made to photographic evidence of flooding in early 1995 and residents' concerns that the culverted drain running along the boundary between the existing development and the proposed development was inadequate and unable to cope with storm water (see Fig. 11).

**Fig. 12** View of Milton Meadows from Kemnay Bridge

**5. Non Return Valves** (such as duckbill); to be fitted to surface water road gully outfalls at Milton Meadows

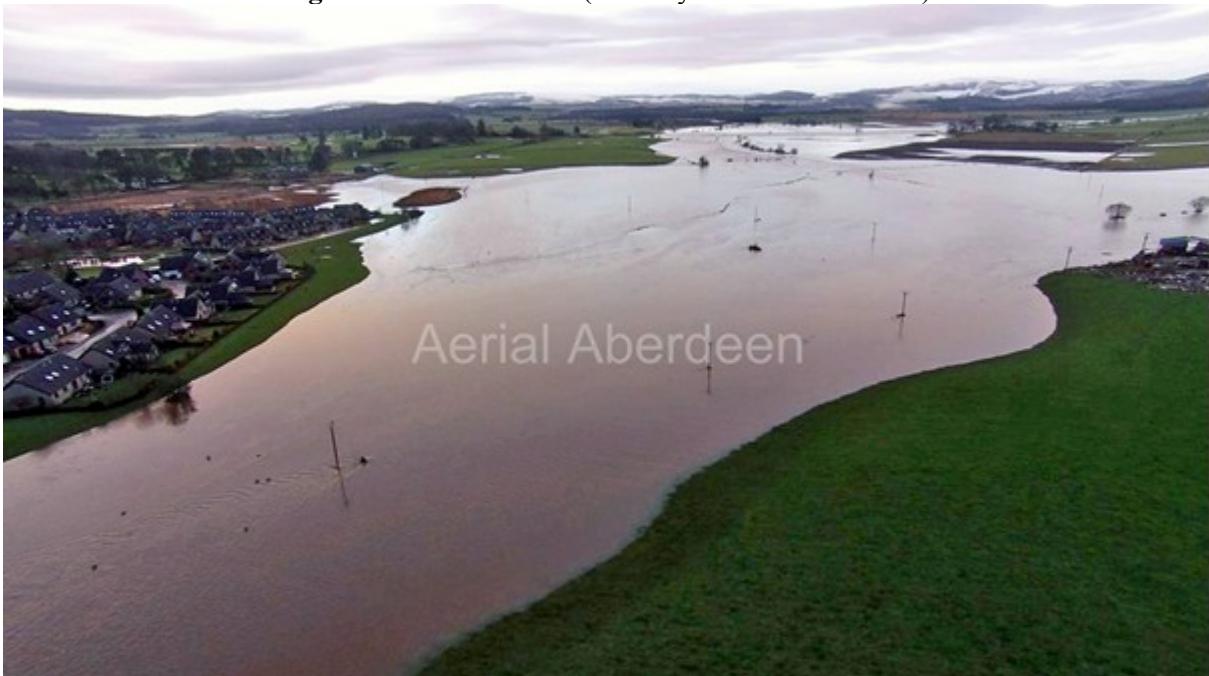
**Fig. 13** Milton Meadows (courtesy of Aerial Aberdeen)

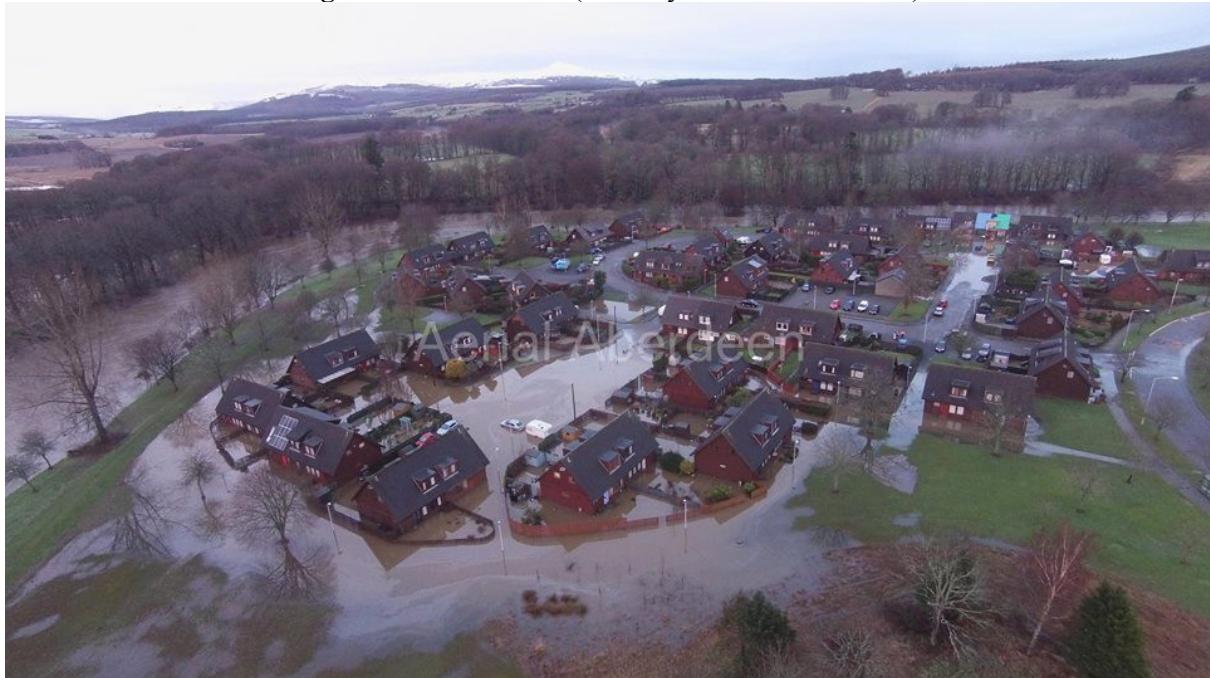
**Fig. 14.** Kembhill Park (courtesy of Aerial Aberdeen)

- a) replace the chain link boundary fence surrounding the Bremner Way Pumping Station with a blockwork wall capable of withstanding floodwater and thereby preventing the escape of raw sewage onto amenity areas and residential properties and

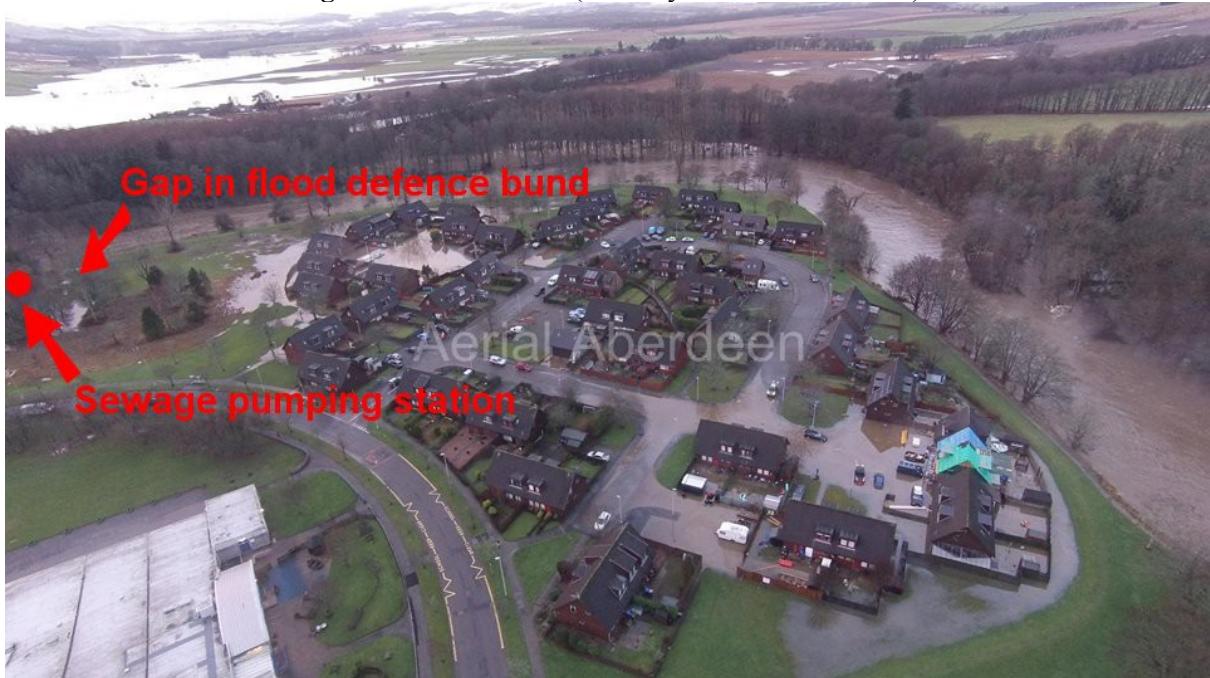
**Fig. 15.** Kembhill Park (courtesy of Aerial Aberdeen)
